**DEPARTMENT OF TRANSPORTATION****DIVISION OF ENGINEERING SERVICES**

Office of Structural Materials

Contract #: 04-0120F4Cty: SF/ALA Rte: 80 PM: 13.2/13.9File #: 1.28**WELDING INSPECTION REPORT****Resident Engineer:**Siegenthaler, Peter**Address:** 333 Burma Road**City:** Oakland, CA 94607**Report No:** WIR-022107**Date Inspected:** 22-Mar-2011**Project Name:** SAS Superstructure**OSM Arrival Time:** 630**Prime Contractor:** American Bridge/Fluor Enterprises, a JV**OSM Departure Time:** 1500**Contractor:** American Bridge/Fluor Enterprises, a JV**Location:** Job Site**CWI Name:** See below**CWI Present:** Yes No**Inspected CWI report:** Yes No N/A**Rod Oven in Use:** Yes No N/A**Electrode to specification:** Yes No N/A**Weld Procedures Followed:** Yes No N/A**Qualified Welders:** Yes No N/A**Verified Joint Fit-up:** Yes No N/A**Approved Drawings:** Yes No N/A**Approved WPS:** Yes No N/A**Delayed / Cancelled:** Yes No N/A**Bridge No:** 34-0006**Component:** SAS OBG**Summary of Items Observed:**

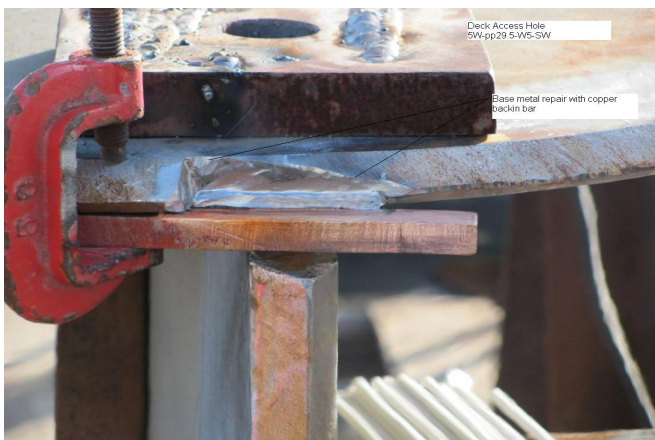
The QA Inspector randomly observed the ABF welder James Zhen preparing the above deck access hole for fit up. The QA Inspector randomly observed the ABF welder and helper grinding bevels of the longitudinal stiffeners and transverse stiffeners under the deck access hole. The QA Inspector randomly observed the ABF welder utilizing a nibbler machine cutting the 45° bevel at the edge of the deck access hole insert. The QA Inspector noted the bevel and bevel angle appeared to meet the general requirements of the contract documents. The QA Inspector previously observed a gouge on the flame cut edge that appeared to be approximately 12mm deep. The QA Inspector noted the base metal was approved by the Caltrans QA Representative Robert Mertz. The QA Inspector randomly observed the ABF welder had ground and blended the gouged flame cut edge to 15mm deep and approximately 80mm long. It was noted a copper backing bar was placed under the ground out area to act as a weld dam to make the SMAW repair. The QA Inspector randomly observed the ABF welder utilizing 1/8" E7018 low hydrogen electrodes with 128 amps to make the repair. The QA Inspector noted the area would be preheat to approximately 200°F and a weld pass was deposited. Then the ABF helper would grind the weld pass and repeat the process. After the repair was completed the areas was restored by welding, the nibbler machine was utilized to cut the 45° bevel into the plate edge of preparation.
